EUROSUN WHOLE HOME WATER FILTRATION SYSTEM

Why the Eurosun Whole Home Water Filtration System?

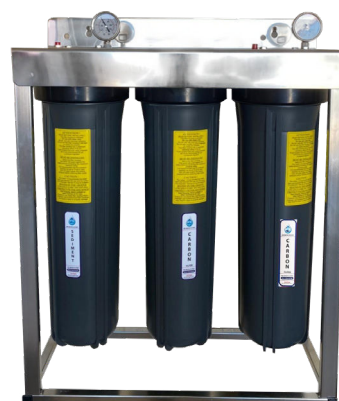
Doubled
capacity filters
to provide more
efficiency to
the filtration &
longevity

- ✓ Cost effective water filtration solution that purifies your home/business entire water supply.
- ✓ High quality components to ensure long life of the system: stainless steel enclosure, gauges frame and brackets.
- ✓ Doubled capacity filters with 20 cm higher than older 10 cm systems in the market. This feature provides more efficiency to the filtration and longevity to the system

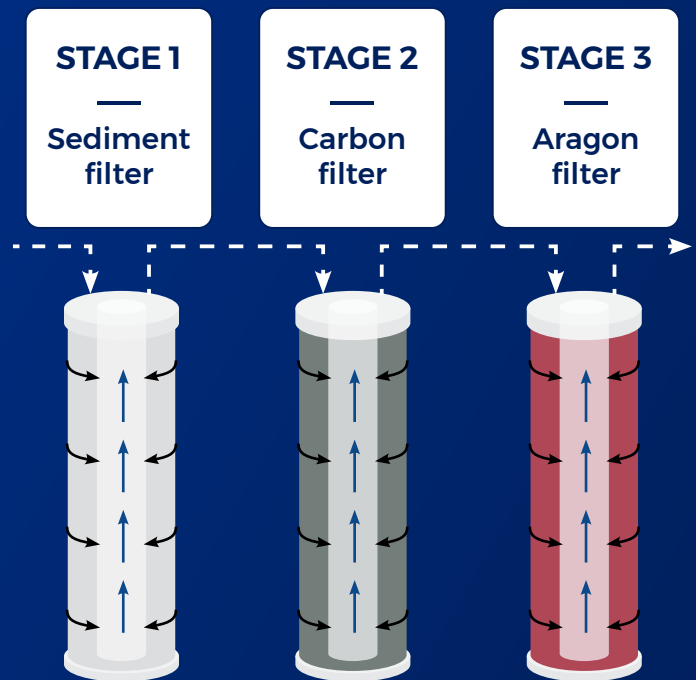
Dimension:
600 W x 740 H x 220 D (mm).

How each filter works?

Stage 1: Sediment Filter

Through a 5 micro polypropylene sediment filter, larger-sized particles from the municipal water are removed to avoid clogging the other 2 filters.

Stage 2: Carbon Filter

Through a 5-micron CTO, carbon block cartridges that contains coconut shell, a natural substance used for creating activated carbon. This carbon block filter has highest quality resulting in premium performance in reliability, absorption, and flow rates. It knocks out 99% of chlorine from the water, taste, odours, pesticides, herbicides and other chemicals.

Stage 3: Aragon Filter

This filter is the latest technology in water filtration. The Aragon cartridge is made in Europe. It allows to achieve the effect of 'quasi-softening', which is a change in the physical structure of hardness salts in water, in such a way that they cease to form solid deposits when heated (scale) while maintaining the natural mineralization of water.
